Used Equipment – The Snake Pit

Pallet Racking

Mezzanine floors

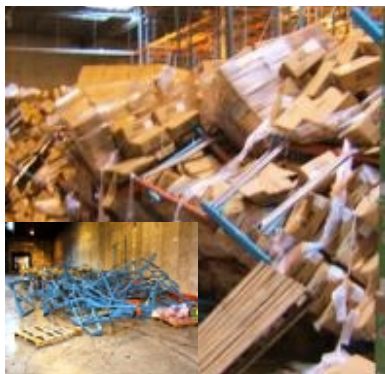
This frame was being subjected to several tonnes of loading in a drive in rack with the name of the supplier proudly displayed at the door. Only one floor fixing bolt had been installed per frame out of the four that should have been in place and even that was very loose!!! Damaged rack is a problem that is usually overlooked or ignored – big mistake!

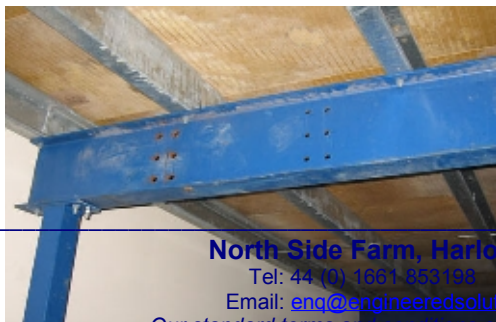
The holes in the web of the blue structural floor beams were there from what we call an inset build. It has been reassembled as an oversailed structure and the buyer has been told it would be safe to take over 500kgs loading per square meter. The thinner cold rolled sections would take this load transmitted onto the blue structural beams but instead of helping to share and distribute the forces they are taking the entire load – weakened by the drilling of the load bearing web clearly visible.

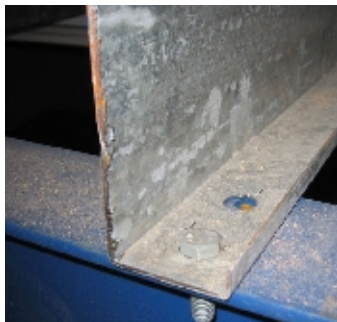
This salvaged section should not have been fitted here. Note the water damage to the floor – which may indicate salvage from fire or flood or very poor storage facilities. Either way it is not fit for purpose. Further evidence that this floor was ready for scrapping off before being sold to our unsuspecting and trusting “mark”.

The bolt you can see has no nut and the second hole is empty.

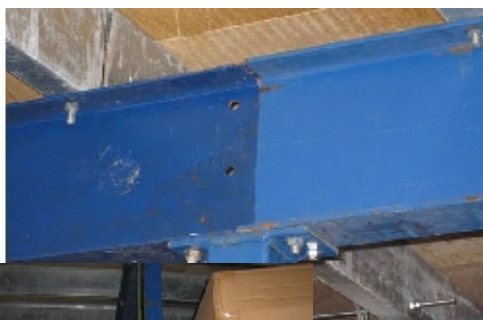
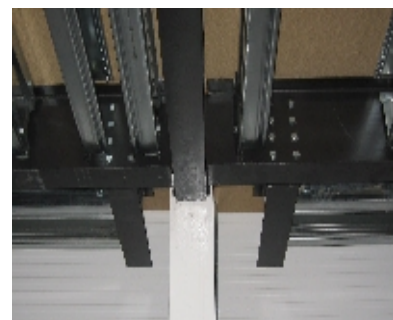
The illustrations to the right above show how the hot rolled sections should be joined on floors I have designed and built. To the left, the bolts are not even tight, the assembly is wrong anyway and it simply was never designed to be used like this.

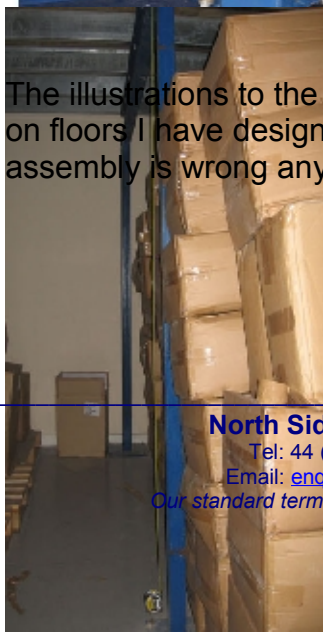
There are joining plates made for fixing cold rolled structures – they would not ever be used for this application (right), nor would

any engineer allow this material to be deployed in this way – it is in permanent danger of collapse.

This is one of the worst sights I have come across. The main load bearing column incorrectly fitted is not even straight, the ground plate was bent and fixings were loose and missing.
