Used Equipment – The Snake Pit

Pallet Racking

Mezzanine floors

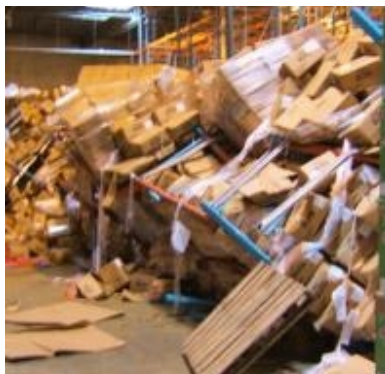
This frame was being subjected to several tonnes of loading in a drive in rack with the name of the supplier proudly displayed at the door. Only one floor fixing bolt had been installed per frame out of the four that should have been in place and even that was very loose!!! Damaged rack is a problem that is usually overlooked or ignored – big mistake!

When catastrophe strikes – and it will, it won't make a sound, metal is a silent killer not like wood which at least creaks and groans before it fails. Thankfully we make them so well that a serious amount of neglect is required for this to occur with European standards governing the creation process.

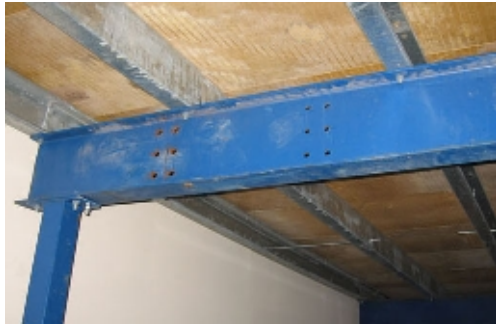
The holes in the web of the blue structural floor beams were there from what we call an inset build. It has been reassembled as an oversailed structure and the buyer has been told it would be safe to take over 500kgs loading per square meter. The thinner cold rolled sections would take this load transmitted onto the blue structural beams but instead of helping to share and distribute the forces they are taking the entire load – weakened by the drilling of the load bearing web clearly visible.

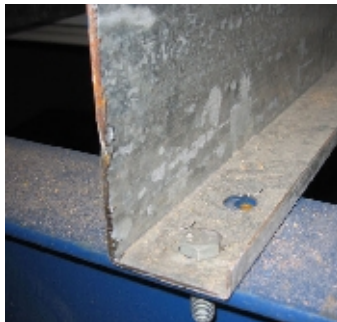
This salvaged section should not have been fitted here. Note the water damage to the floor – which may indicate salvage from fire or flood or very poor storage facilities. Either way it is not fit for purpose. Further evidence that this floor was ready for scrapping off before being sold to our unsuspecting and trusting “mark”.

The bolt you can see has no nut and the second hole is empty.

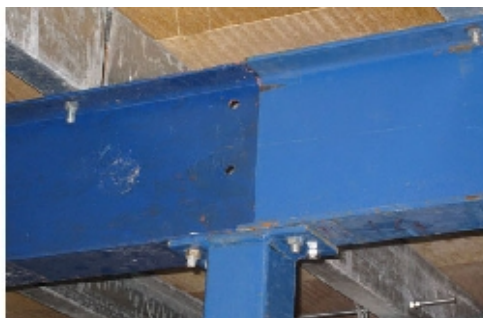
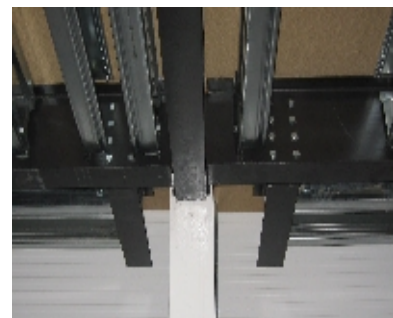
The illustrations to the right above show how the hot rolled sections should be joined on floors I have designed and built. To the left, the bolts are not even tight, the assembly is wrong anyway and it simply was never designed to be used like this.

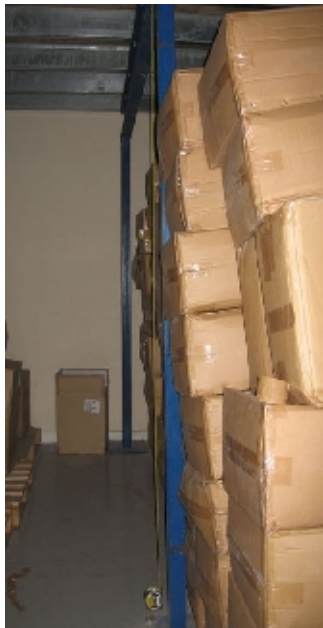
There are joining plates made for fixing cold rolled structures – they would not ever be used for this application (right), nor would any engineer allow this material to be deployed in this way – it is in permanent danger of collapse.

This is one of the worst sights I have come across. The main load bearing column incorrectly fitted is not even straight, the ground plate was bent and fixings were loose and missing.
